## Weak modifications testing

Report Identifier: 13780-RP-001-REV01

Prepared for: Fundynorth Fishermen's Association

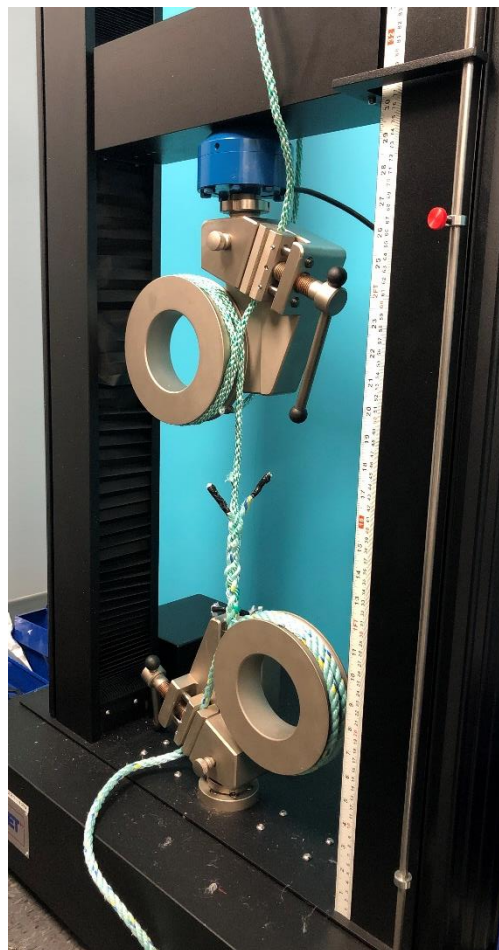
FIGURE 1: TEST BOLLARD GRIP SETUP

Tensile tests were conducted using a ADMET model: 1220FHH-10K-B test machine, The calibration and certification sheet can be seen in Appendix A. Each sample was placed into the bollard grips such that the required testing section was positioned between the grips with a gauge length of approximately 12 in. This test setup can be seen in Figure 1, shown below. The tensile test was focused on the area where the weak modification is spliced or attached to the normal buoy line. The test was focused on this area because stress concentrations are introduced into the rope system whenever it is spliced or tied. These stress concentrations will decrease the load carrying capacity of the rope. This means that if two ropes are spliced together it will always fail at the splice (DMR, 2018). The test sample was then pulled at a constant rate of 20 in/min until failure. This was repeated five times for each of the six total modifications. The test results were logged to CSV file and then imported into Excel for charting and characterization. Those charts and summary data for each test is presented in the results sections below.

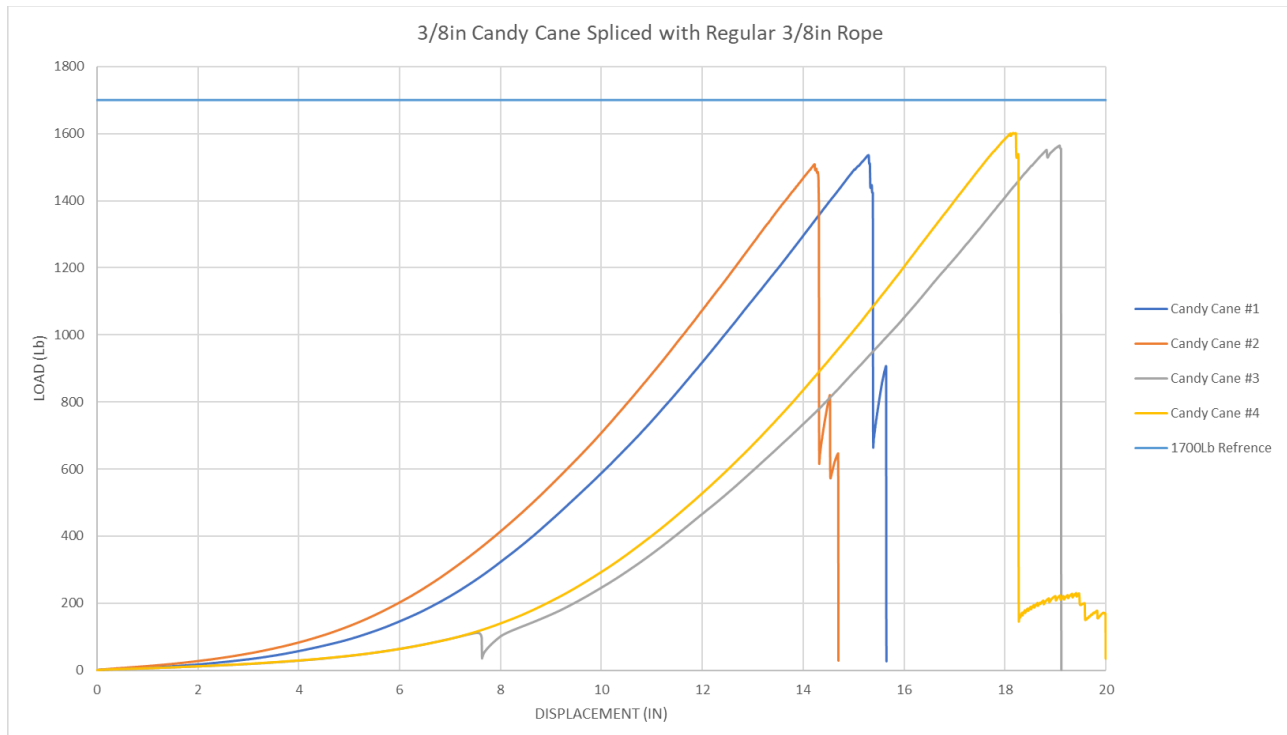
FIGURE 2: 3/8 CANDY CANE TENSILE TEST PLOT

In order to understand all the charts in the following sections, a description of this first chart (Figure 2) is required. The X-axis displays the displacement and the Y-axis shows the load. The Admet machine automatically resets the displacement to 0 in just as the load exceeds 1 lb to ensure that the data, and therefore the charted output of all specimens are aligned. The charted output of every sample tested has an initial curve where the rope tightens around the bollards and it is only during the linear section of that all the displacement is being absorbed in the stretch of the modification (or its splice to the adjoining section of rope). This linear section continues until the modification fails and there is a rapid drop in load. A vertical drop means an instantaneous break. A sloping drop means the failure occurs over some additional displacement. Spikes in the drop likely indicate whipping or contact with the frame of the test machine..

In this case specifically (Figure 2) Candy Cane sample #3 undergoes a sharp drop in Load after 7.5in of travel. This indicates a point where a wrap of rope on the fixtures was initially crossed and then dropped into place. The expectation therefore is that sample #3 appears to stretch more than it actually did, and this is evident as at-break it was around 1in further stretched than the next nearest sample (#4).

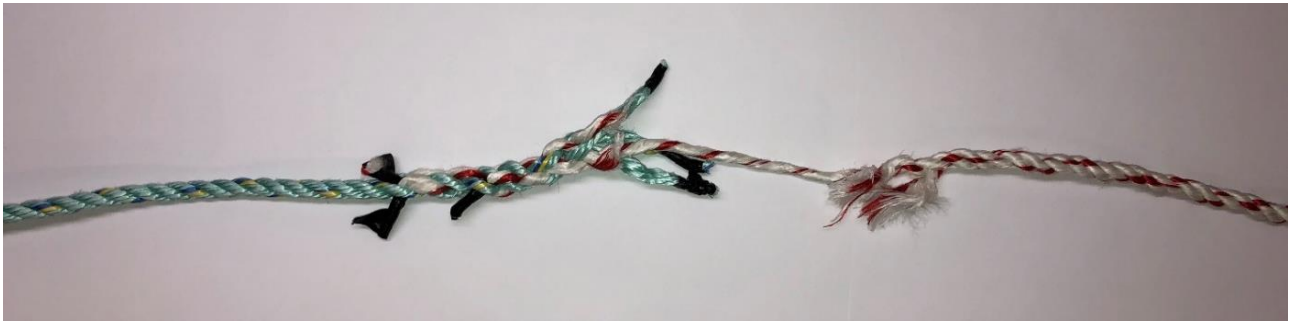
FIGURE 3: 3/8" CANDY CANE SAMPLE #1

The 3/8" candy cane sample failure shown in Figure 3 shows that two of the three twisted braids broke within the splice to the regular 3/8" rope. This sample had a stretch of about 15" at the point of break. The average break point for this product was 1409.6lb with a standard deviation of 128.1lb. This average is quite some distance from 1700lb target, but the high standard deviation shows means that there was a high variance between the tested samples. Although, even with this low average and high variation, no sample broke above the 1700lb threshold.

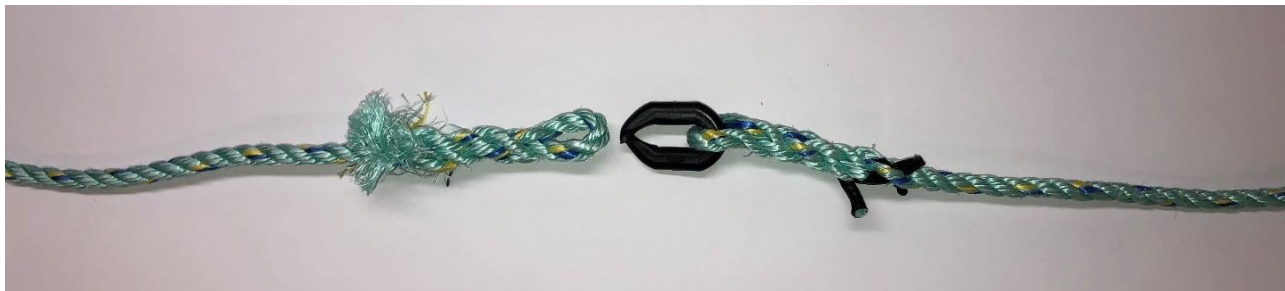
FIGURE 5: SEASIDE IN-LINE LINK SAMPLE #1

The Seaside In-Line Link sample shown in Figure 5, it is seen that this sample breaks at the plastic link between the two splices. This sample had a stretch of about 10" at the point of break. The average break point for this product was 1524.9lb with a standard deviation of 74.5lb. This standard deviation was on the lower end compared to the other samples. All samples broke below the 1700lb threshold. The failure of the link goes through a plastic deformation prior to failure. This is shown in the gradual decrease in load before failure. This plastic deformation is the link stretching and necking at the failure point. This stretch within the

sample can be seen in Figure 5 as the deformation on the failure side. This plastic deformation could decrease the load capacity of the sample if the sample experienced cyclic loading into the plastic region.

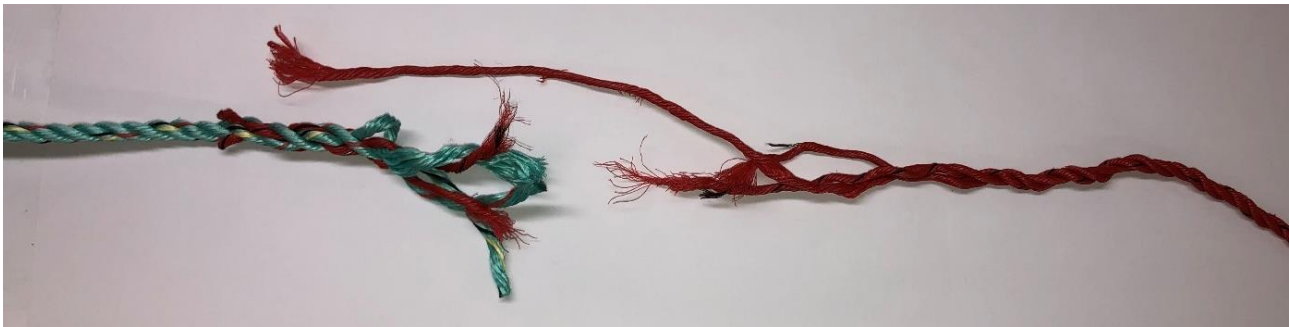
FIGURE 7: 5/16" POLYETHYLENE SAMPLE #1

The 5/16" Polyethylene sample shown in Figure 7: 5/16" Polyethylene Sample #1, it is seen that the sample breaks within the splice between the two ropes. This sample had a stretch of about 18" at the point of break. The average break point for this product was 1807.9lb with a standard deviation of 144.6lb. This standard deviation was the highest of the samples tested. This high variation compounds with the average for the samples being larger than the 1700lb threshold.

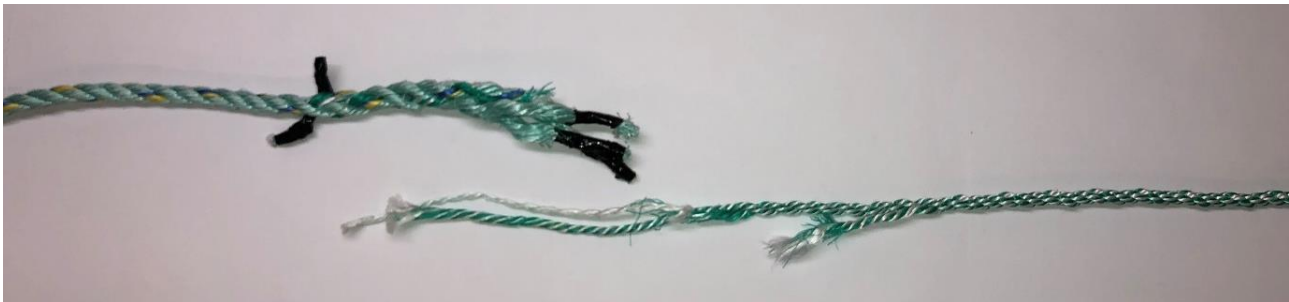
FIGURE 9: 5/16" CREELINE SAMPLE #1

The 5/16" Creeline sample shown in Figure 9: 5/16" Creeline Sample #1, it is seen that the sample breaks partially within the splice between the two ropes. This sample had a stretch of about 16" at the point of break. The average break point for this product was 1848.6lb with a standard deviation of 111.7lb. This standard deviation was one of the highest of the samples tested. This high variation compounds with the average for

the samples being larger than the 1700lb threshold. This sample would fail partially within the splice while the other strands of rope would pull out of the splice. This multistage failure would cause spikes in the load displacement curve. These spikes can be seen in Figure 9 after 14" of displacement,

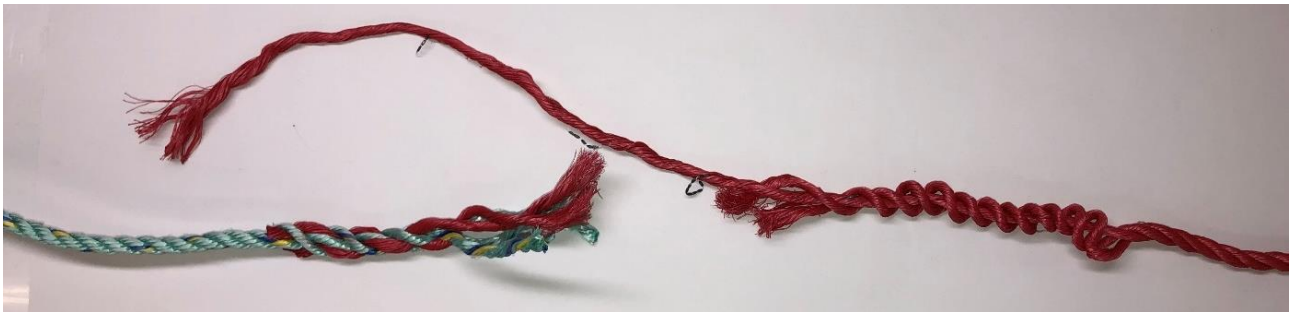
FIGURE 11: 3/8" TUFF ROPES SAMPLE #1

The 3/8" Tuff Ropes sample shown in Figure 11: 3/8" Tuff ropes Sample #1, it is seen that the sample breaks within the splice between the two ropes. This sample had a stretch of about 17" at the point of break. The average break point for this product was 1525.8lb with a standard deviation of 20.9lb. This standard deviation was lowest of the samples tested. This low variation in values shows how consistent the splice and rope can be. No sample exceeded a break above the 1700lb threshold, but the highest break force was 1551lb. The Tuff

Ropes sample consists of a leaded core within the 3 strands. Upon failure of the sample the lead core would be ejected from the splice. It appeared the strand that contained the lead would stretch less than the strands without the lead. This would cause the strands to fail at different points. As seen in Figure 11, the strands without the lead broke within the splice while the strand with the lead pulled out of the splice.

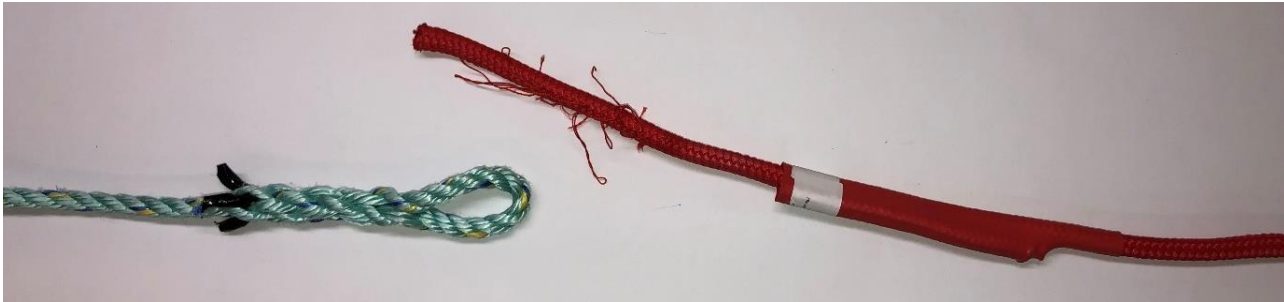
FIGURE 13: COASTLINE SAMPLE #1

The Coastline Link sample shown in Figure 13, it is seen that the sample breaks at the stitched section of the splice. This sample had a stretch of about 6" at the point of break. The average break point for this product was 1618.8lb with a standard deviation of 77.3lb. This standard deviation was the lowest compared to the other modification tested. This modification required a low total stretch to break and averaged a maximum

break below the 1700lb break threshold. One single test exceeded 1700lb, by 35lb. This modification would fail completely and suddenly once it reaches the failure point. This complete failure combined with the low standard deviation makes this a predictable sample.

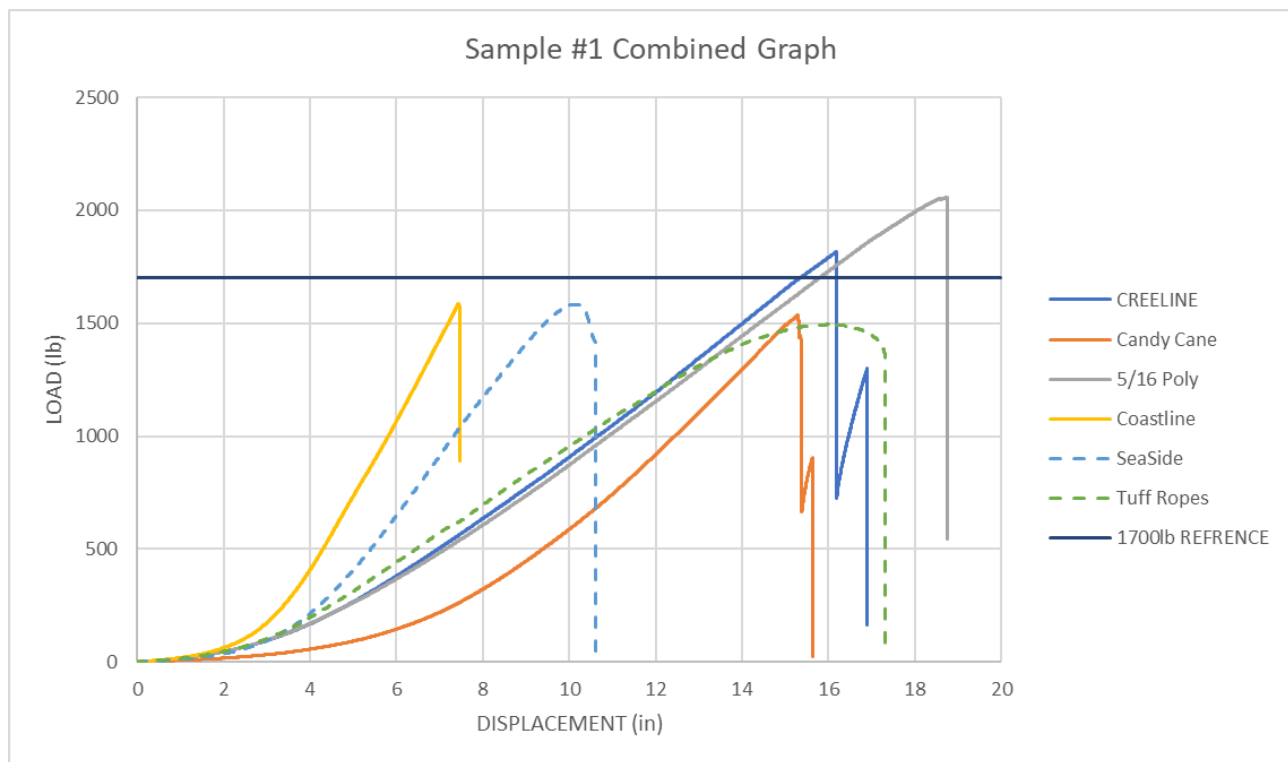
FIGURE 14: SAMPLE #1 COMBINED GRAPH

The graph below (Figure 14), represent the Load Vs. Displacement of each 1<sup>st</sup> sample tested. This graph directly compares the displacement required at the break points of each modification. The stretch of the modification is a combination of the quality of the splice and the material of the modification. The displacement at failure is an indication of the stiffness of the system. A modification that has a low stretch will have a more sudden inelastic failure. This type of sudden failure will happen quickly with little indication that the sample is about to fail which may be undesirable from a fishers perspective.
